**Flood Control Project Maintenance  
Levee Inspections**  
**LMA District Cover Sheet**  
**Spring 2019 Levee Inspection Results**

**Sacramento River West Side Levee District**

**Spring 2019 Levee Inspection Results**

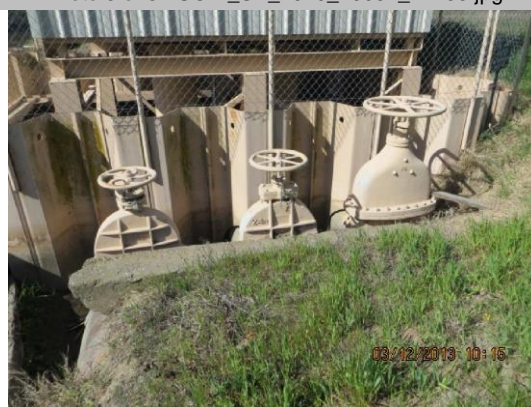
Photo 3 of 3 : UCIP\_SP\_2019\_10087\_17233.jpg

Slide gates at pumphouse on LS toe.

Comment Code						
Inspector Comment						
FS_ID:10085						
DS_ID:20356						
EP_NO: N/A						
Repair Type: Non-Urgent						
Crossing Status: Found						
UCIP Comments: Headwall undermined 3-4-feet on WS toe.						
FIELD_STRUCT_DESC: 2 of 3: 36-inch steel drainage pipe through the						
levee, 30 feet below the crown. Flap gate on the waterside (WS) end.						
24-inch pipe sleeved through the 36-inch pipe. Annular space between						
pipes grouted. Pumps inside pump house with a walkway on the						
landside (LS) toe. [Additional Reference(s): DWR Levee Log, 2006.						
USACE Sacramento O&M Manual 130, May 1960 (HLM 0.15)].						
FS Date: 3/12/2013

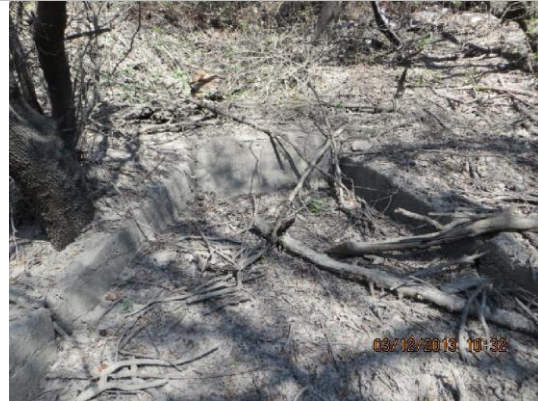
Photo 1 of 1 : UCIP\_SP\_2019\_10088\_17237.jpg

Concrete headwall visible on WS toe.

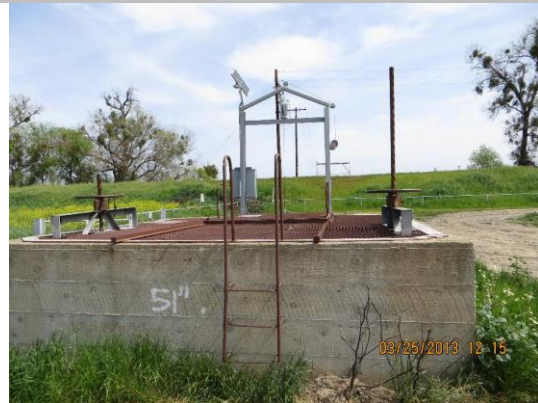
Photo 1 of 3 : UCIP\_SP\_2019\_10103\_17262.jpg

Comment Code					
Inspector Comment					
FS_ID:10103 DS_ID:20226 EP_NO: 1331 Repair Type: Non-Urgent Crossing Status: Found UCIP Comments: There is no gate in the slide gate at the concrete distribution box off the landside toe. This may not be an issue as there is a slide gate at the WS toe. FIELD_STRUCT_DESC: 54-inch corrugated metal irrigation pipe through the levee, 28 feet below the crown. Vertical pumps on a pile structure in the stream. Walkway to pumps. Flap gates from pumps and slide gate inside a 7-foot by 10-foot concrete surge box on the waterside (WS), 1948 installation. 15-foot by 18-foot concrete distribution box 150 feet off landside (LS) toe with slide gate. (Permit No. 1331, 1948 - River Farms Company of California). [Additional Reference(s): DWR Levee Log, 2006. USACE Sacramento O&M Manual 130, May 1960 (HLM 0.47)]. FS Date: 3/25/2013 7:36:51 AM

Concrete distribution box on 150-feet off landside toe.

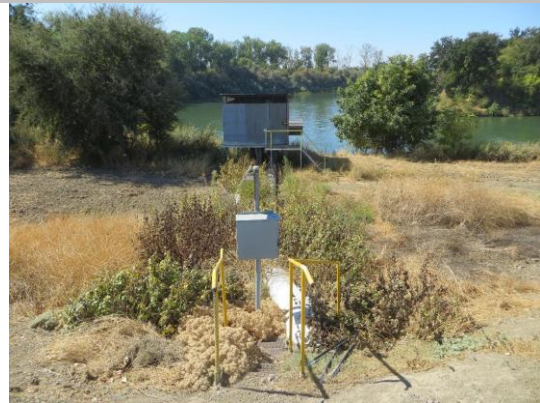
Photo 1 of 3 : UCIP\_SP\_2019\_46766\_74705.jpg

view from levee crest along pipe looking towards water side. shows pipe daylight and pump house

Comment Code						
Inspector Comment						
FS_ID:46766 DS_ID:25126 EP_NO: 8501 Repair Type: Non-Urgent Crossing Status: Found UCIP Comments: a few actions are recommended based on field inspection: 1. clear out metal fence posts near daylight of pipe on water side levee. 2. clear vegetation around pipes on water side of levee to aid in inspection. 3. monitor burrowing activities on water side of levee. FIELD_STRUCT_DESC: 2 of 2: 20-inch steel irrigation pipe, at an unknown depth, and 16-inch steel irrigation pipe, at an unknown depth, are located at levee mile 6.889 and 6.89, respectively. Both pipes have a protective paint coating. The pipes are used to supply irrigation water to the adjacent fields. On the waterside (WS) of the levee, the pipes are above ground and follow the slope of the bank into the river. A metal pump house, supported on a steel frame, is located on a bench on the WS of the levee. When the pumps are operational, a drum fish screen is lowered over the pipe intakes on a track. Both irrigation pipes travel through the levee and have siphon breakers inside corrugated metal riser units on the landside (LS) crest of the levee. The pipes discharge under submerged conditions to a 9.5-foot by 12-foot concrete distribution box. There are two gated outlets on the distribution box that lead to distribution canals. FS Date: 10/9/2015

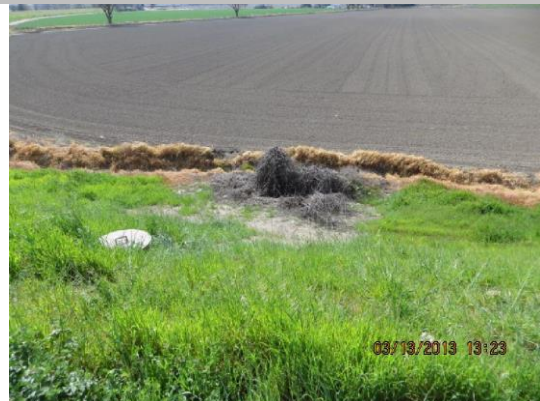
Photo 1 of 2 : UCIP\_SP\_2019\_10253\_17449.jpg

CMP Riser on shoulder and concrete distribution box under heavy blackberry cover at LS toe.

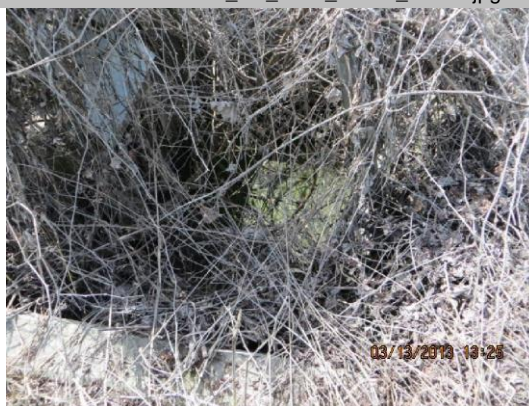
Photo 2 of 2 : UCIP\_SP\_2019\_10253\_17448.jpg

Concrete distribution box under heavy blackberry cover at LS toe.

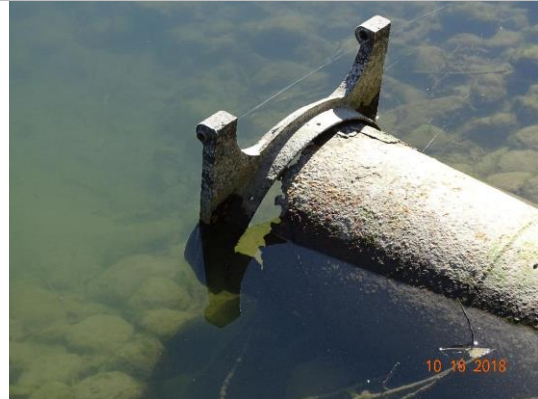
Photo 1 of 3 : UCIP\_SP\_2019\_53988\_78171.jpg

Missing flap gate on WS end. Pipe is corroded through.

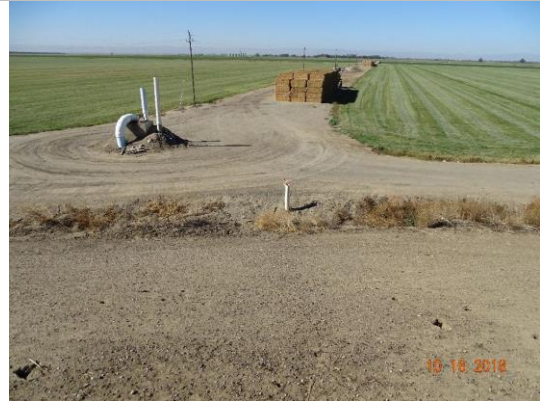
Photo 3 of 3 : UCIP\_SP\_2019\_53988\_78169.jpg

Pipe is not found on LS. Appurtenances on LS are not associated with this crossing.

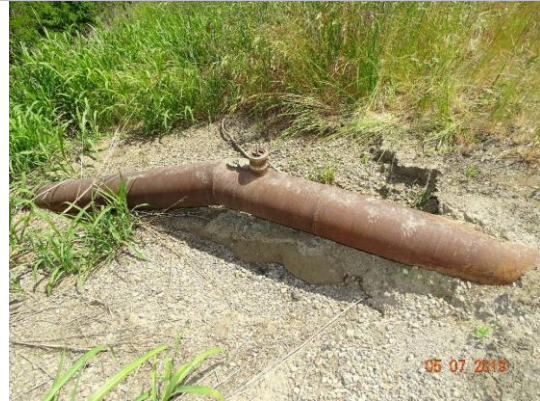
Photo 3 of 3 : UCIP\_SP\_2019\_54061\_79356.jpg

Erosion on WS slope around pipe

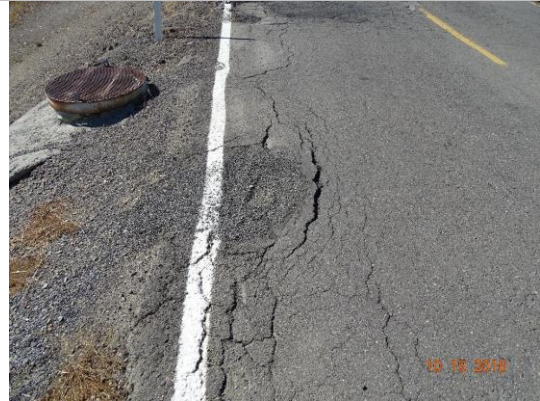
Photo 1 of 3 : UCIP\_SP\_2019\_53020\_78180.jpg

Multiple cracks and poits of depression on levee crown.

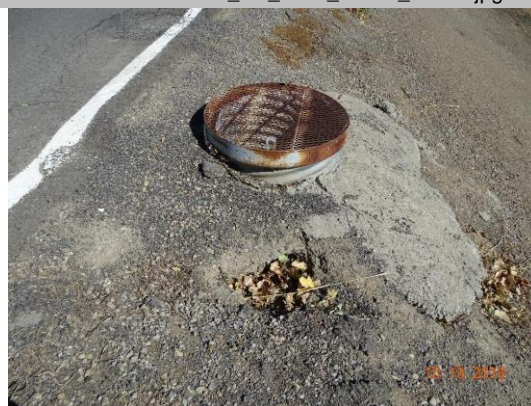
Photo 3 of 3 : UCIP\_SP\_2019\_53020\_78176.jpg

A sinkhole next to CMP riser on LS shoulder.

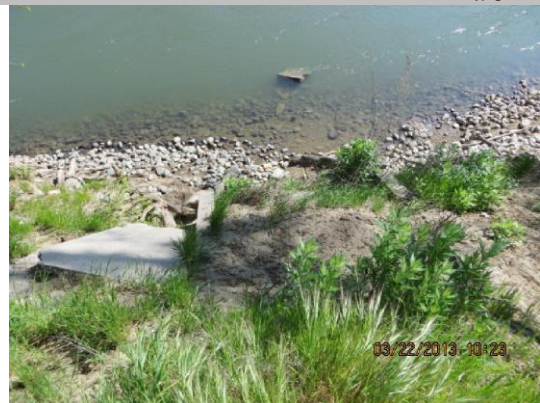
Photo 1 of 2 : UCIP\_SP\_2019\_10563\_17941.jpg

Concrete pump house debris on WS berm.
